## CERTIFICATE OF COMPLETION & REPORT

Cooling Tower Refurbishment – 1 Evapco Cooling Tower

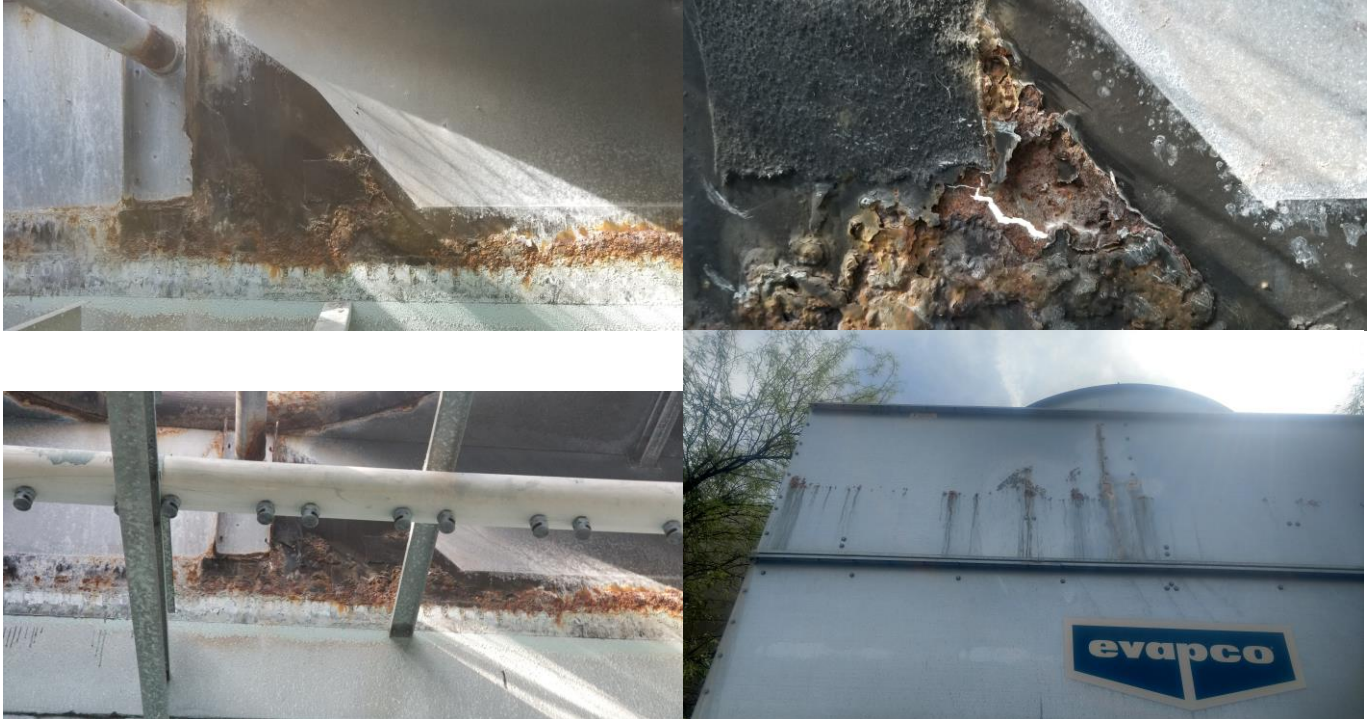
After removing all the media inside the tower (drift eliminators, 3' of fill and louvers) we observed severe corrosion happening on the top section of the tower. The area of utmost concern is securing the fan support which is in jeopardy of caving in. We didn't feel comfortable grinding or sandblasting these areas for coating because of all the holes we would've punched through on the top section. We decided to add a 2"x2" piece of angle that secured to the fan support bracket and the upper tower wall to provide more support. We scraped the outside loose of debris and rust from the surface then coated the remaining metal to prevent as much growing corrosion on that line as possible.

Pictures of the corroded upper deck and previous coating around compromised support before repairs.

We highly recommend the upper section of the tower be replaced to avoid complete failure and can be completed over a weekend. We will have a price to complete this as soon as possible. We also recommend the towers be mechanically cleaned from top to bottom at least once a year moving forward.

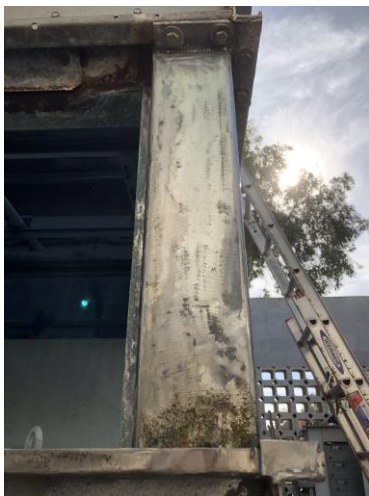
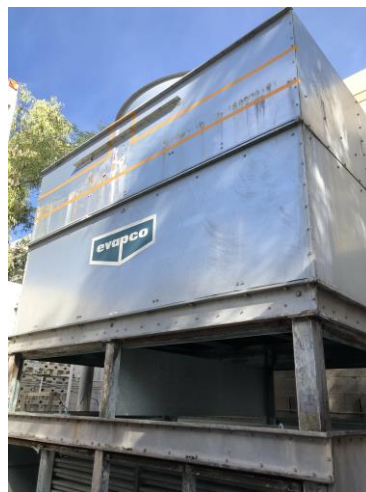
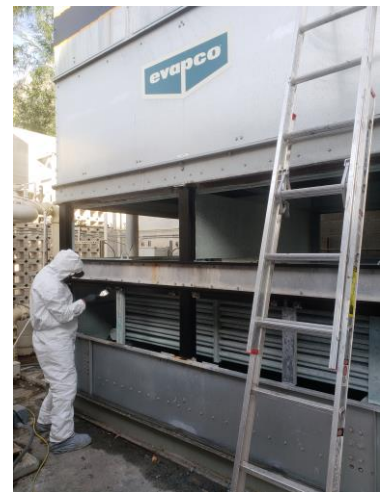
In lieu of coating the upper drift eliminator section as proposed we focused on the louver frames and vertical supports which were showing some corrosion. These were grinded clean, prepped and coated.

Pictures prep work being done on tower and coating being applied to supports

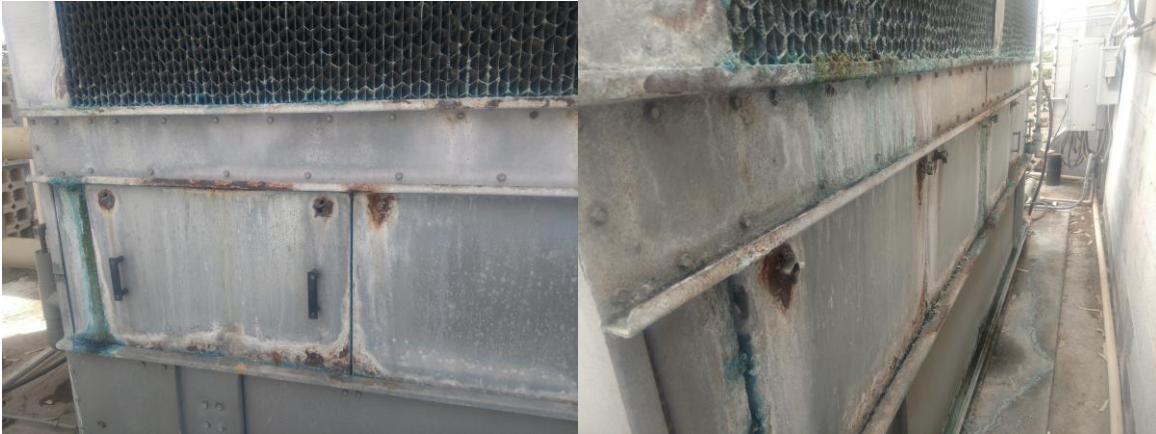
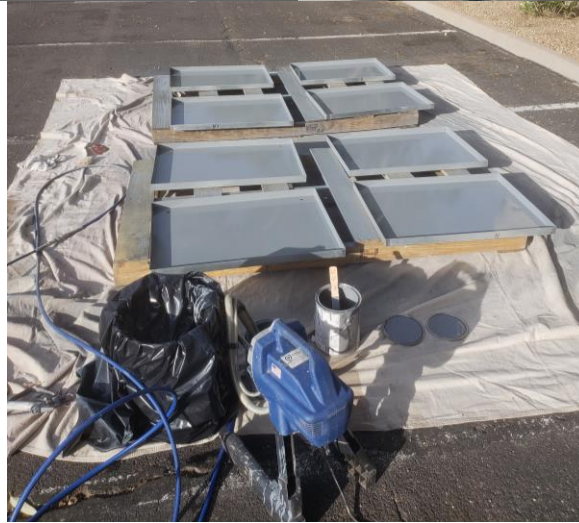
The new fabricated steel access panels with welded on handles were prepped, cleaned and painted with a specialty rust preventative metal paint.

Old Panels and New Access Panels after having been coated inside and out

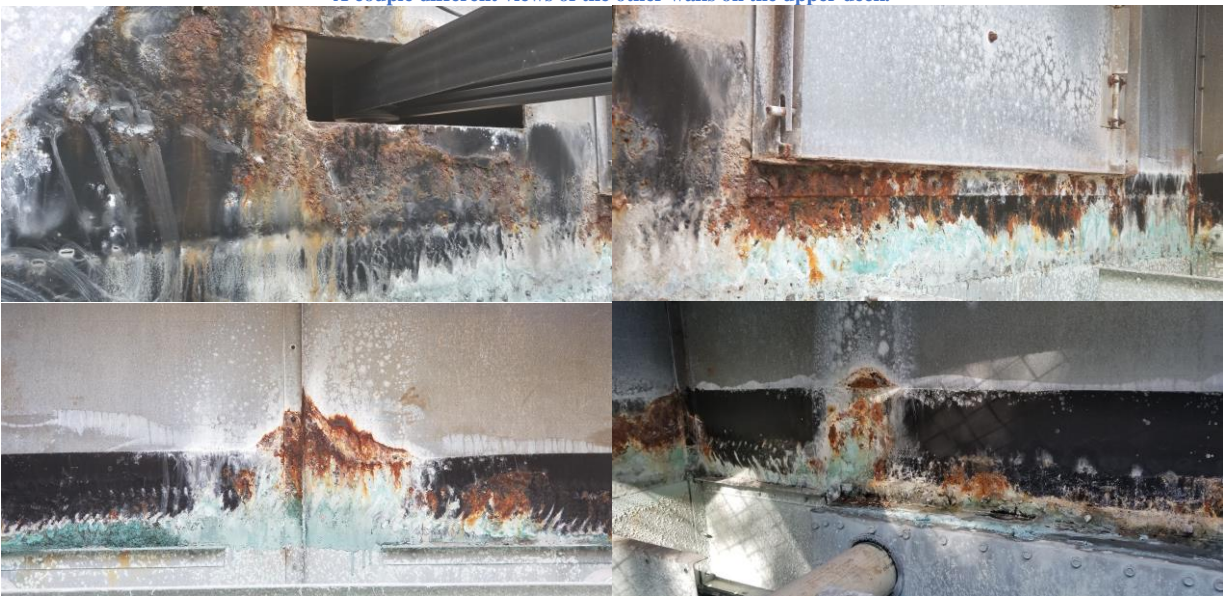
A couple different views of the other walls on the upper deck.

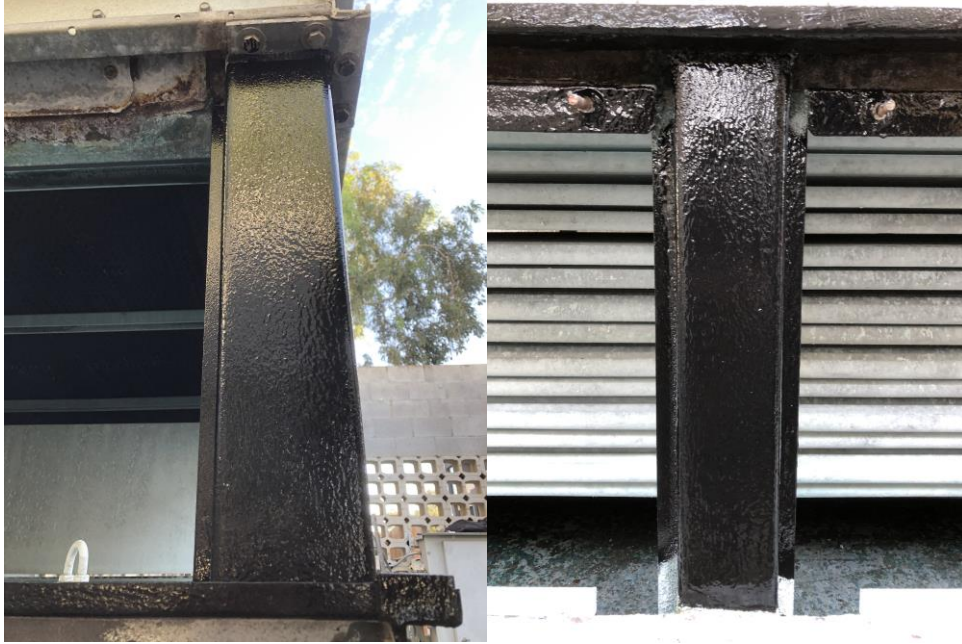
Coating on the supports

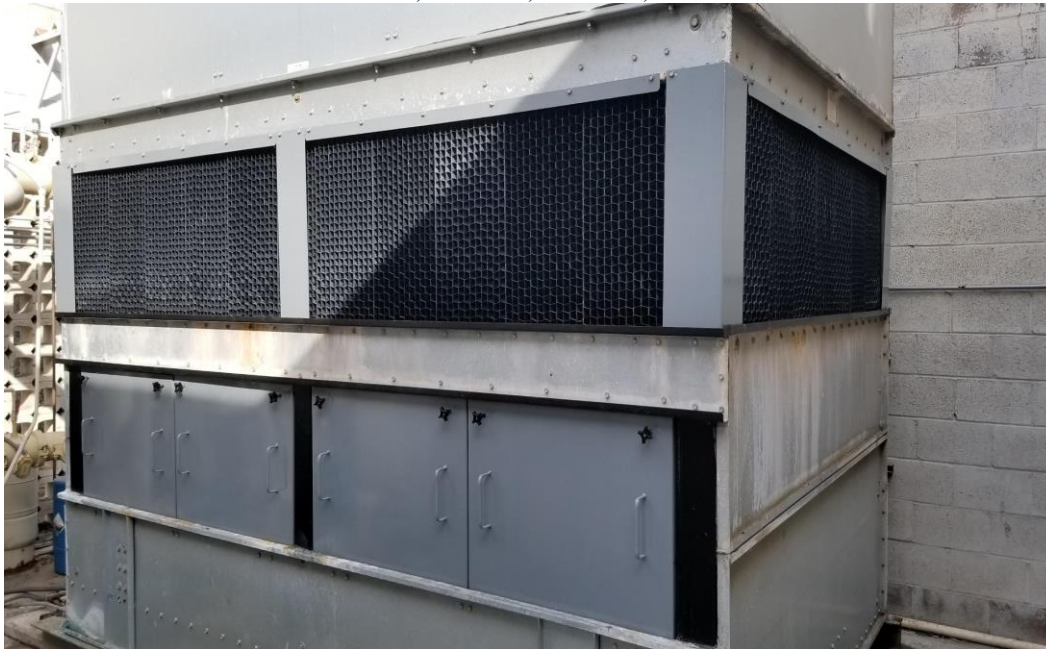
Access Panels, new Knobs, coated trim, and Louvers

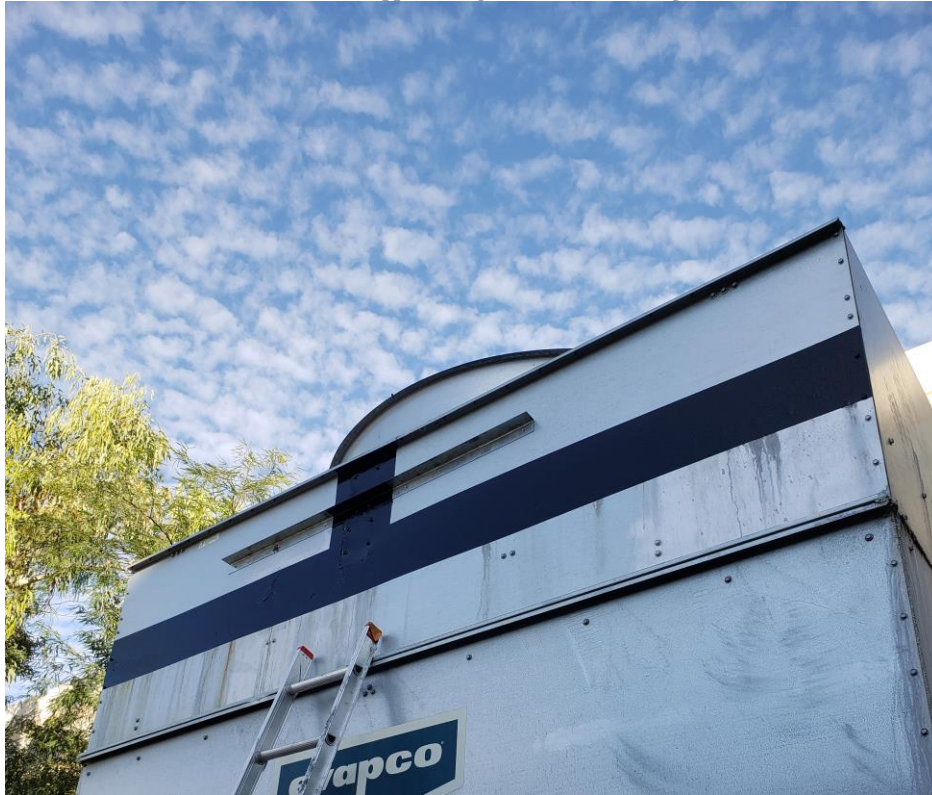
Reinforced upper casing with exterior coating

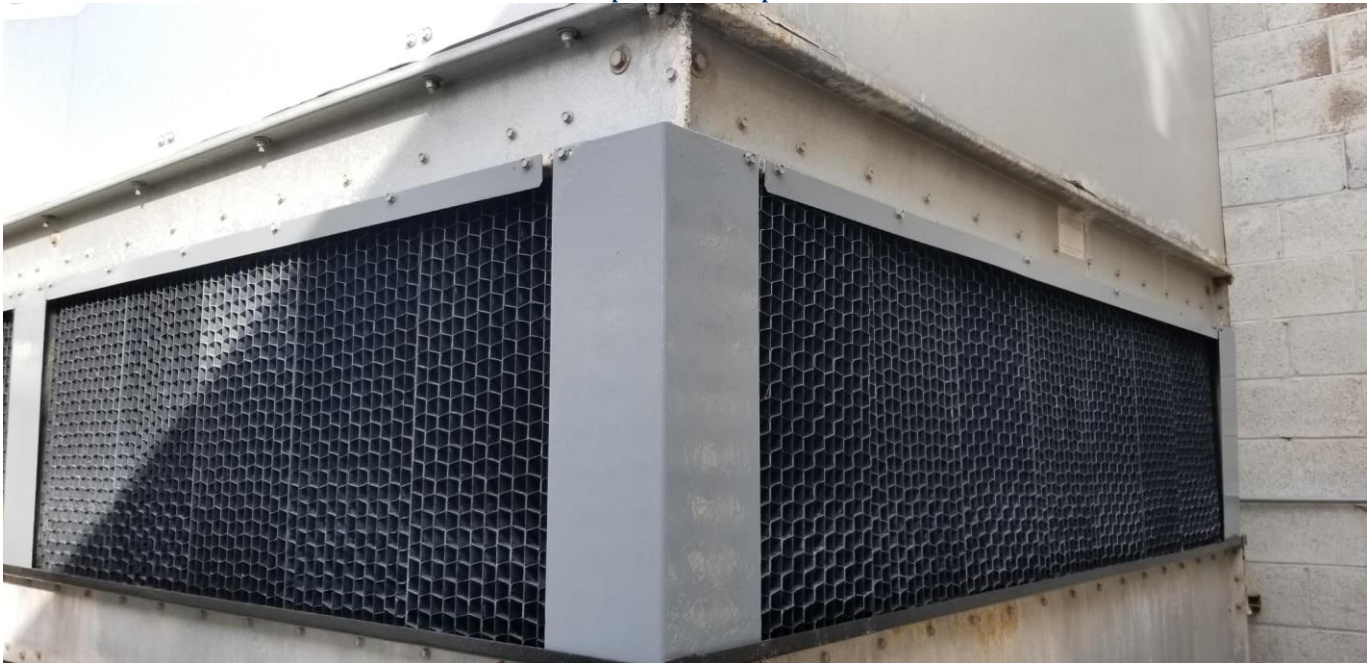
Close up of coated trim panels.
