## CERTIFICATE OF COMPLETION & REPORT

Deep Coil Cleaning Program

Provide “Deep Coil Cleaning Program” project for HVAC coil cleanings; to include deep Eco Coil Clean, clear water rinse & EcoSustain Preventative application. Purpose of cleanings is to improve energy efficiency, improve Indoor Air Quality, and extend the life expectancy of units, as well as documentation of findings to demonstrate effectiveness of the program.

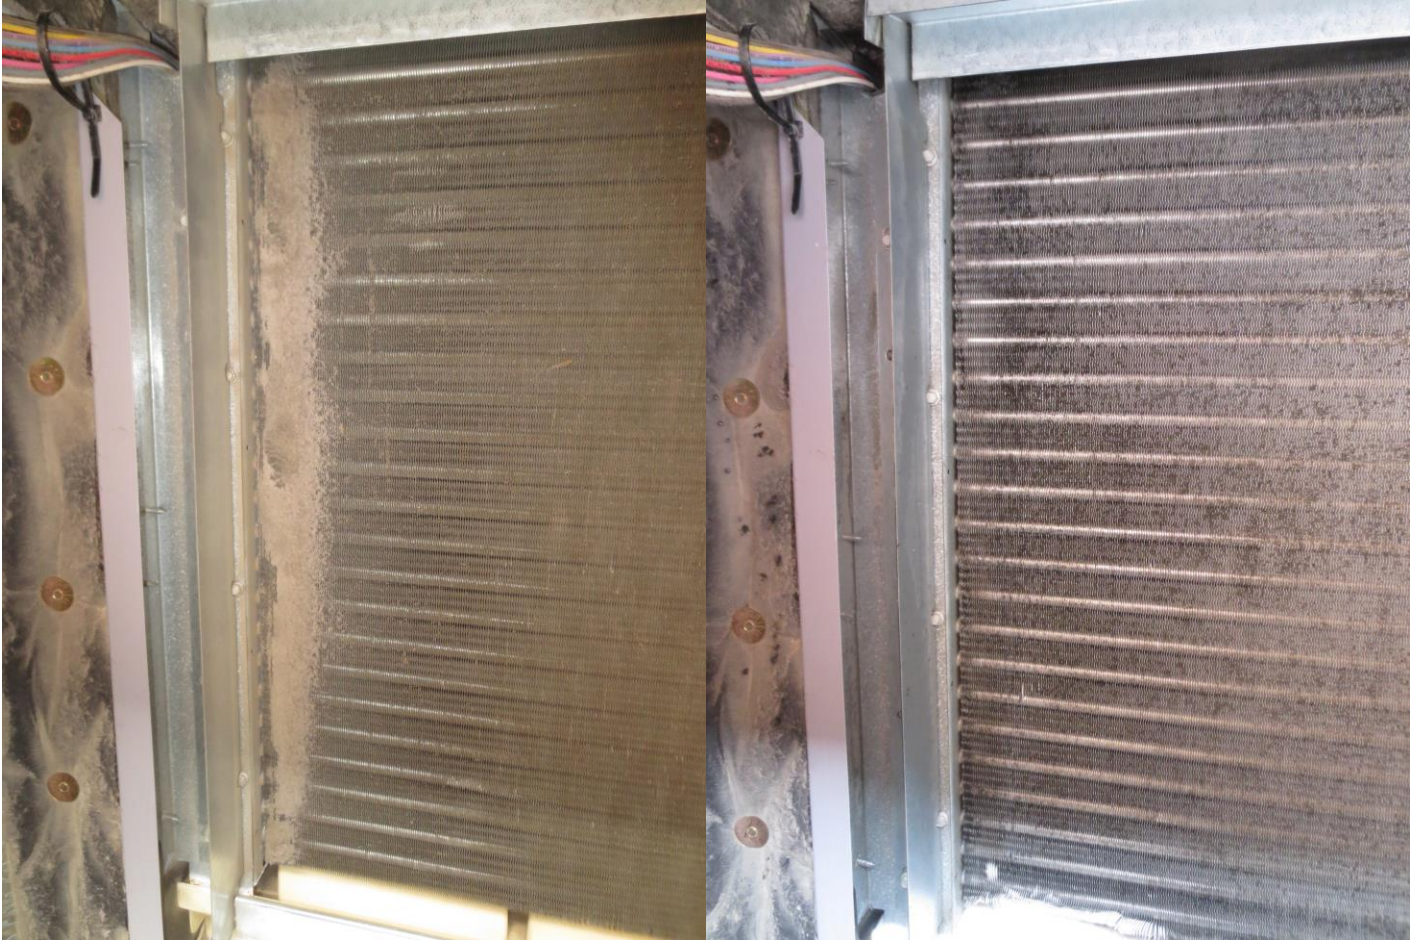
This is a before and after look at a rooftop package unit at [REDACTED]. This is typically what we saw on these types of units.

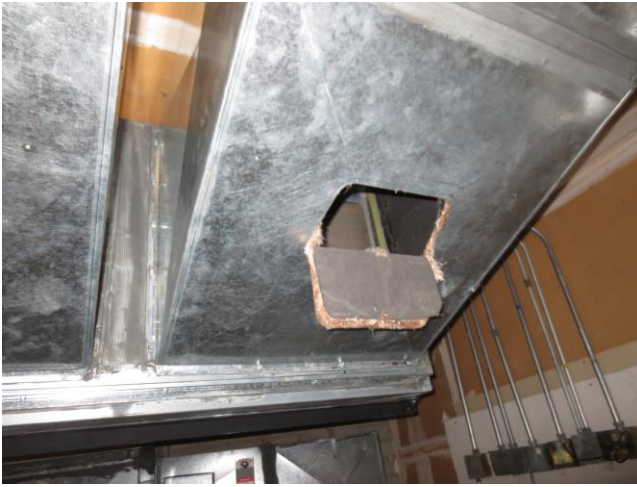
This is the access panel cut into the AHU @

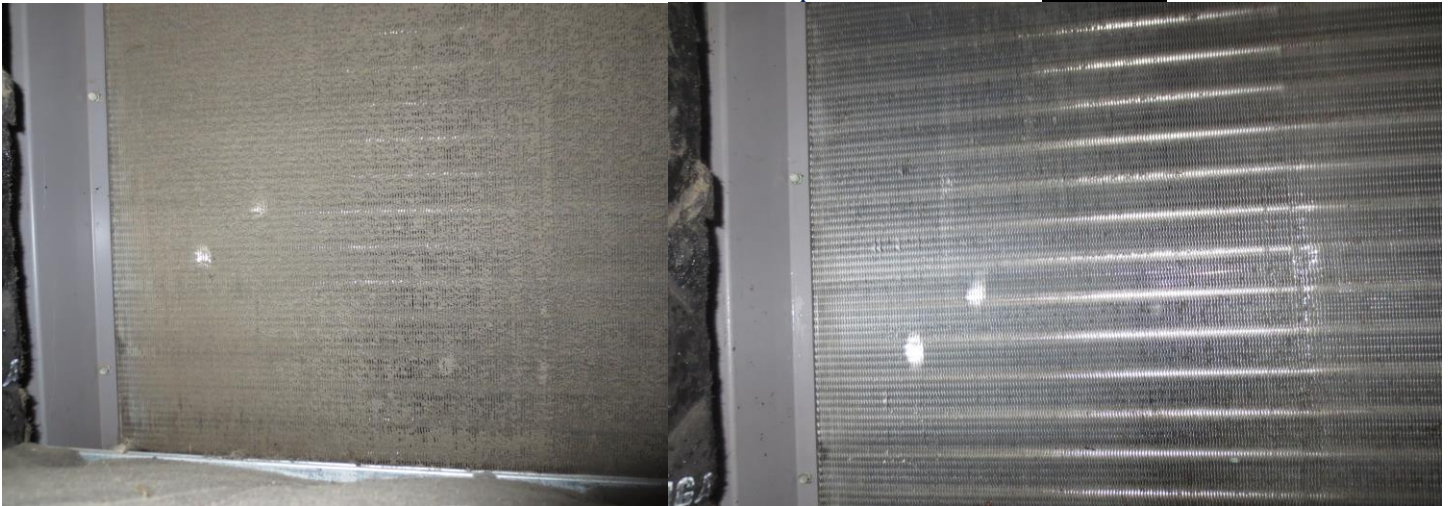
Above is a before and after look at the coils inside the access panel we cut. Below is a look at the coil during the cleaning.

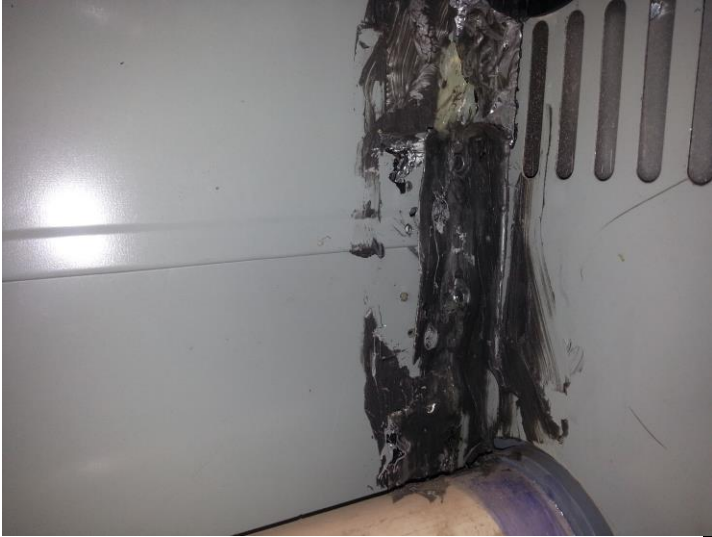
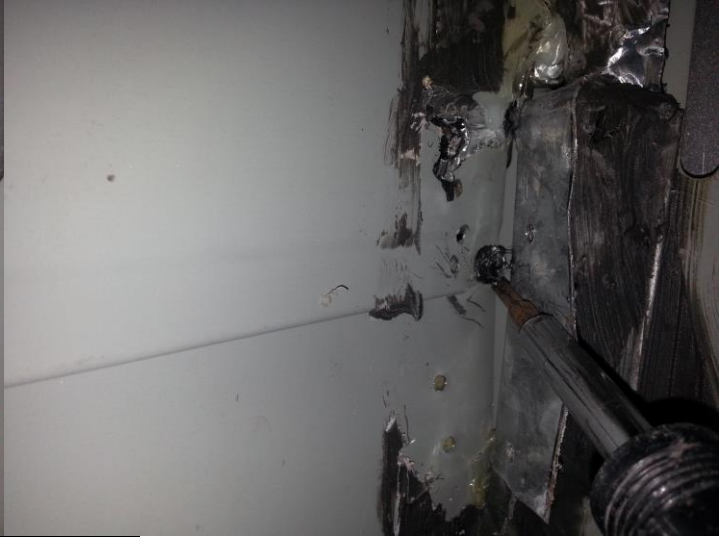
Above is a look at how we had to access the coils on the above ceiling units at

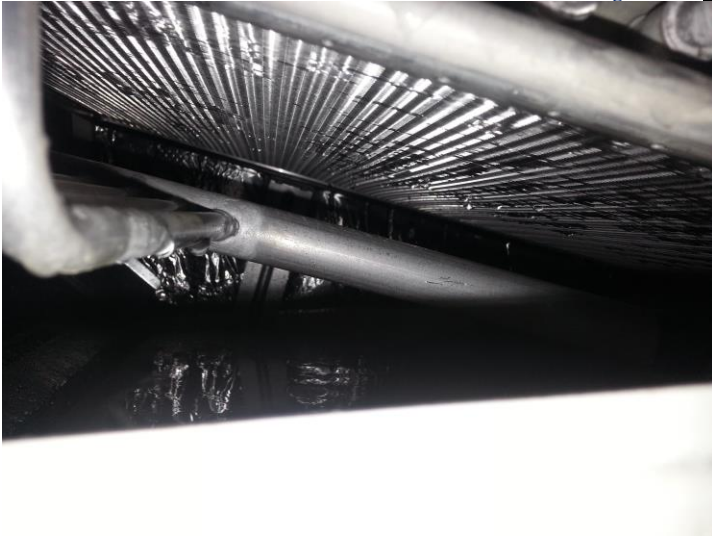
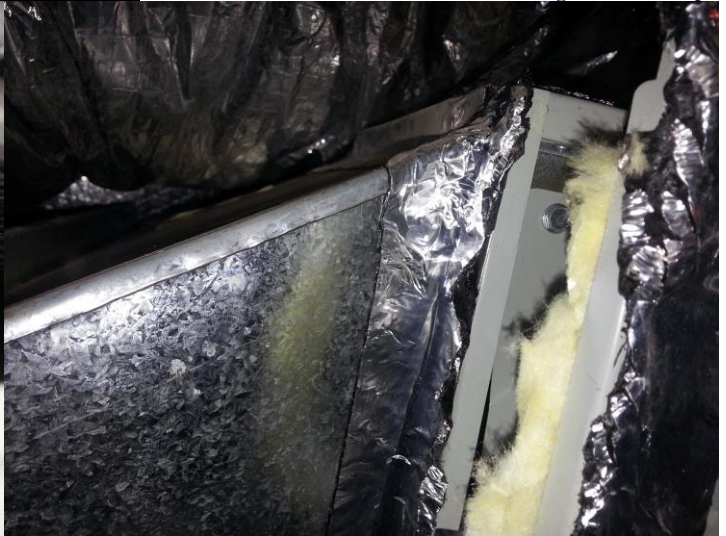
. Below is the access to the coils and after being sealed back up.

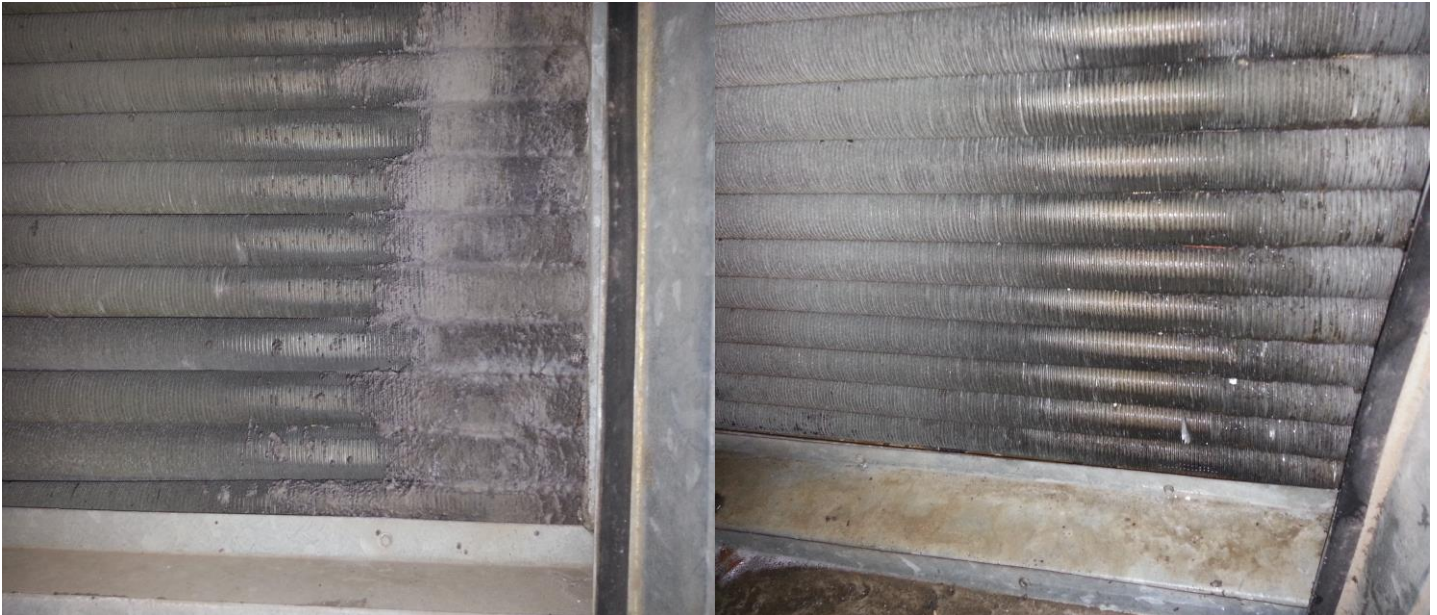
This is a before and after look at one of the Main Air Handlers at [REDACTED]. These are older units with “coin style” coils that are typically very tough to get penetration through the coils. We were able to get penetration through the coils despite the heavy debris.

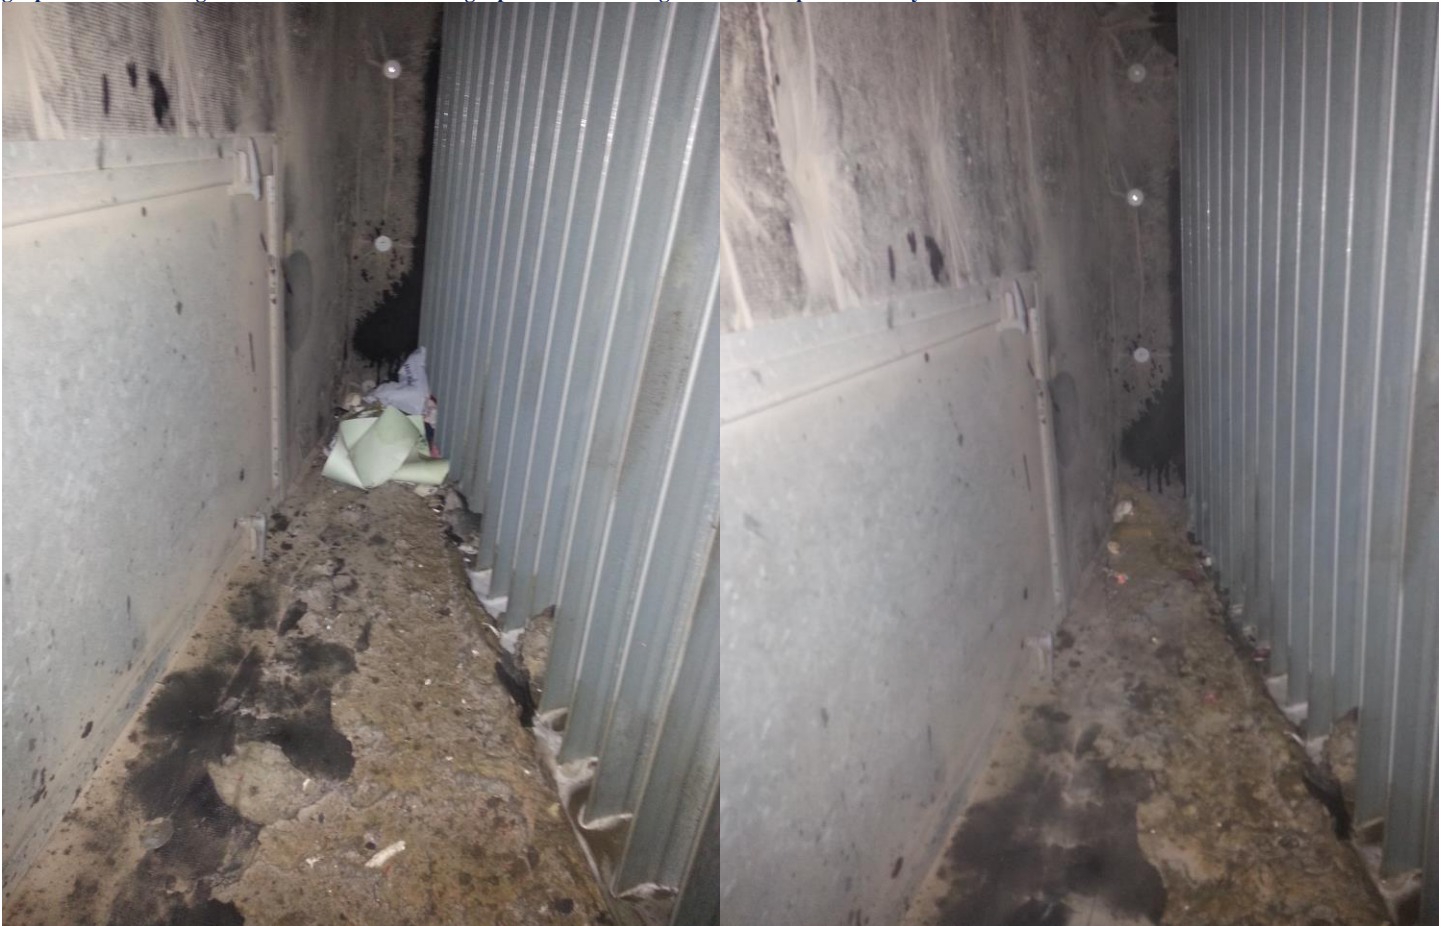
This is a main AHU at [REDACTED] with a bunch of accumulated debris that we cleaned out of the unit before cleaning the coils. The brown is old insulation.

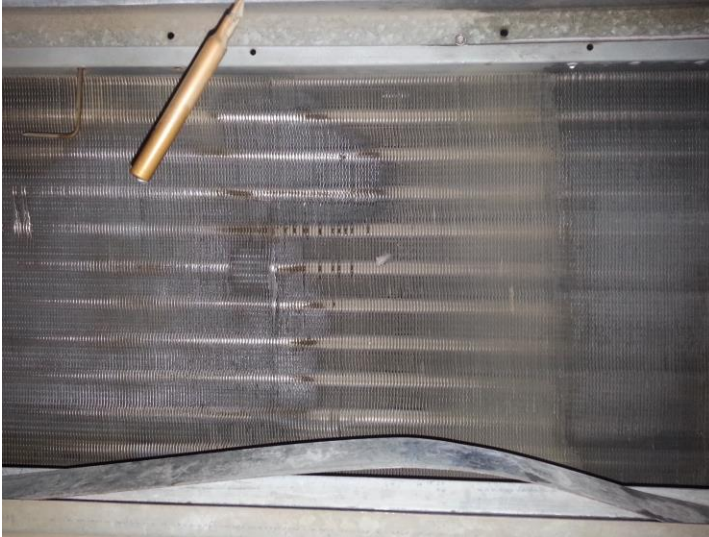
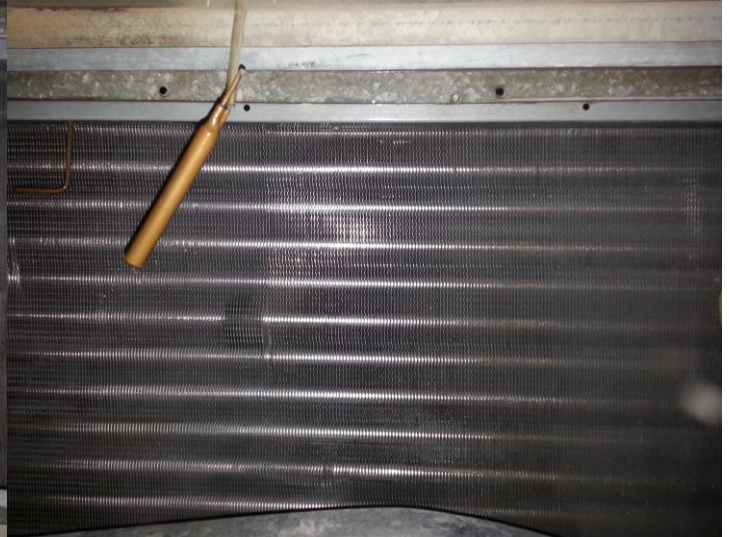
Above is a before and after look at the coils in the main AHU at [redacted]. Below is a look at the condenser coil on the unit to the right during cleaning.

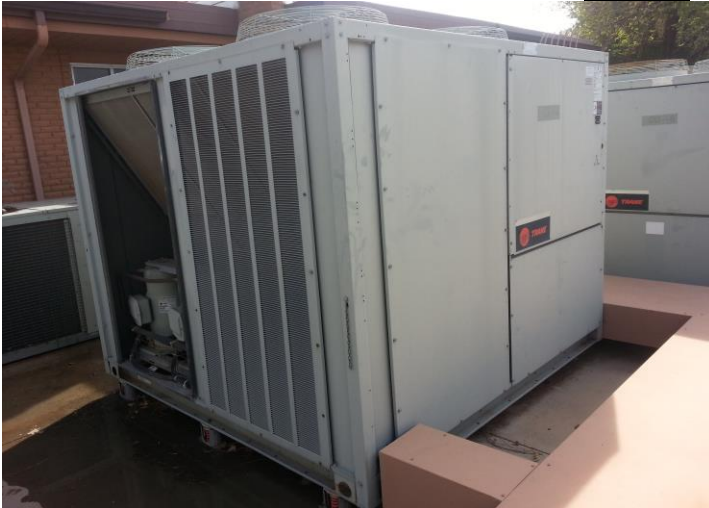
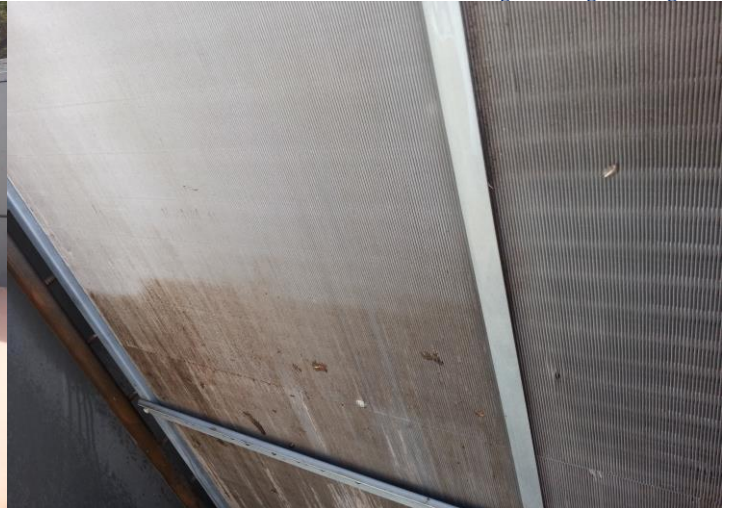
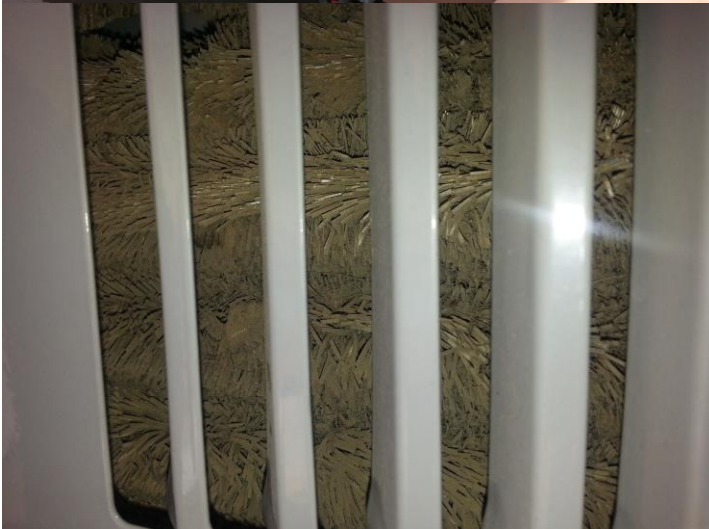
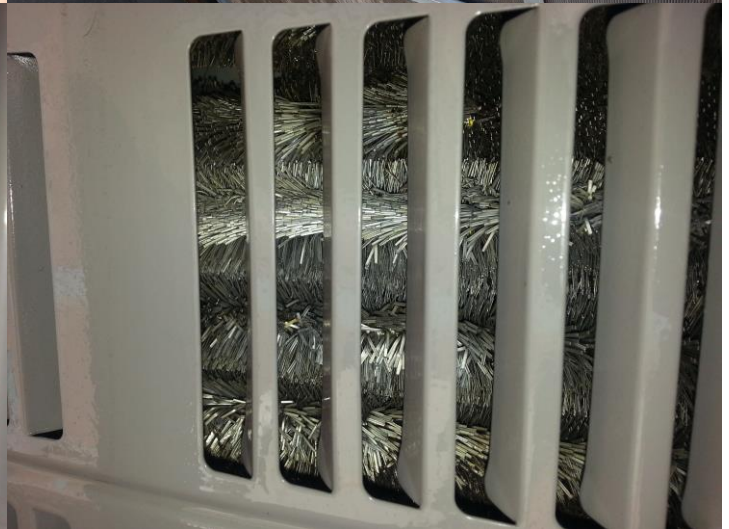
Above is a before and after look at the condenser coils at [redacted].

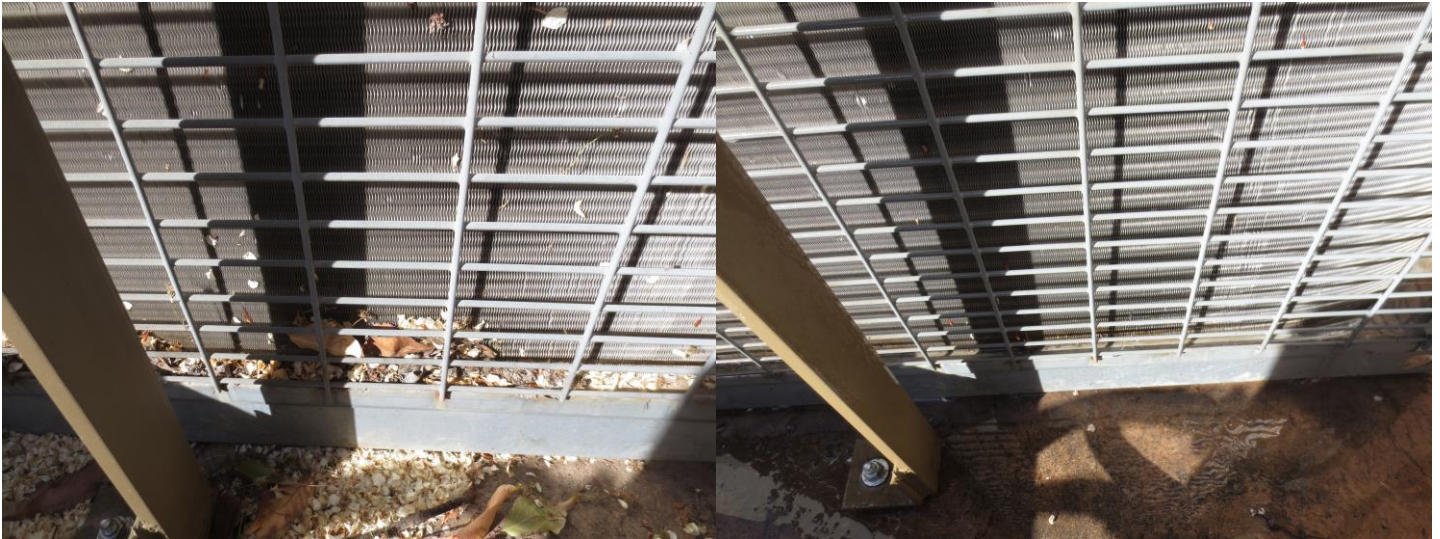
Above is a before and after look at a condenser unit that had a tremendous amount of leaves and debris all over the units restricting airflow.

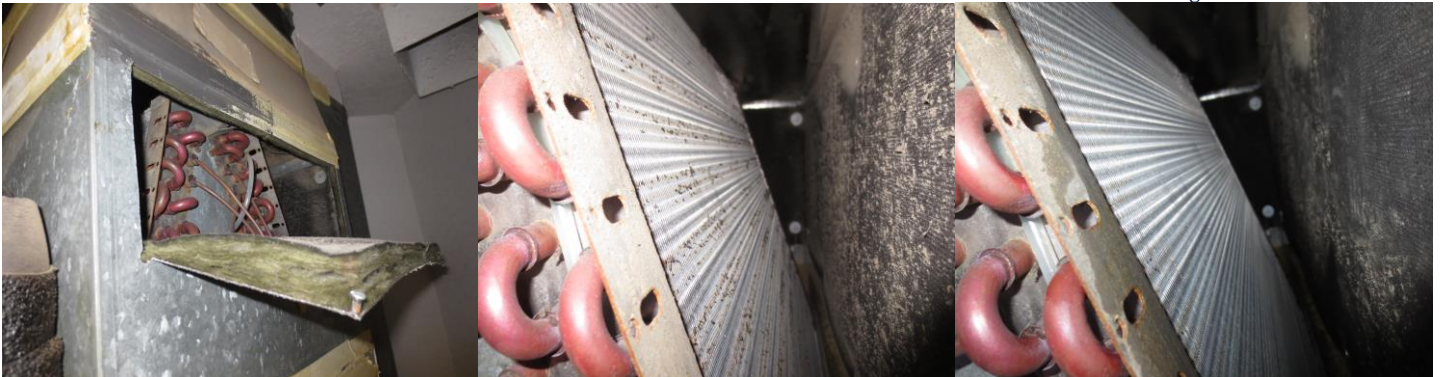
Above is a look at what we typically saw at the 5 churches where we cut access panels.

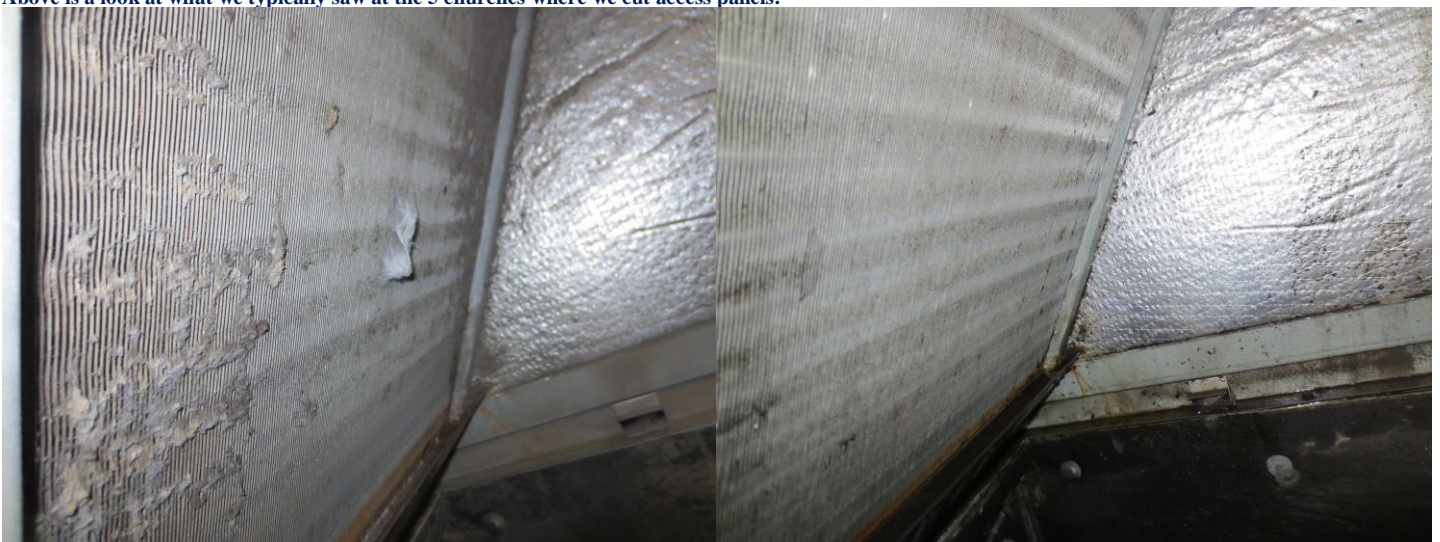
This is a before and after look at a unit at [REDACTED]. These units were really dirty and saw some oxidation exposed after the cleaning.
