CERTIFICATE OF COMPLETION & REPORT

Evap Cooler Refurbishment – 1 Evaporative Cooler Unit
[REDACTED]

Work Completion Dates: June 3rd- June 8th, 2019

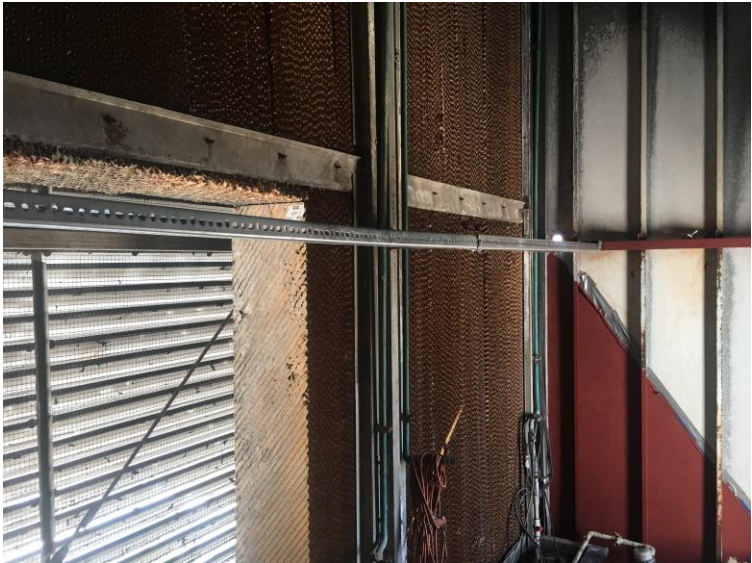
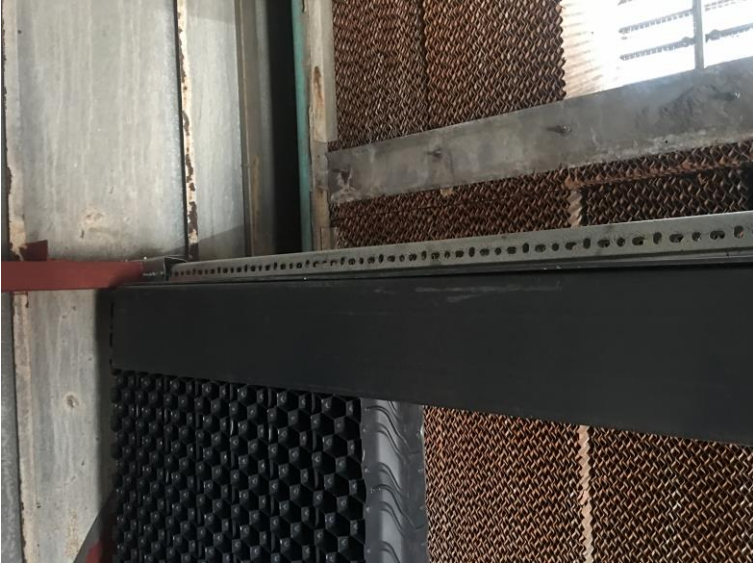
Above are views of the supports built to hold the 6” drift eliminator track in place. Below is a section of the supports installed with drift eliminators.

The drift eliminator sections were installed in front of the cell-dek media above the sump to reduce the moisture coming through to the motors and plenum of the unit causing havoc to everything in the unit. We custom built a frame support on the ceiling, middle bracing area and sump composed of a heavy gauge 6" utility angle. These frames were attached with stainless steel hardware to prevent any corrosion. The roofs of each unit were sealed with silicon where the hardware attached the frames to the roof. The utility angle was the perfect sizing so the drift eliminators can slide back and forth and be replaced easily. There were notches cut on each end to accommodate the different valves and actuators on the units. Each piece of drift was hot wired to ensure a perfect fit. We think the frames of these units can last forever with proper cleaning and maintenance annually along with changing the drift eliminator media every 5 years.

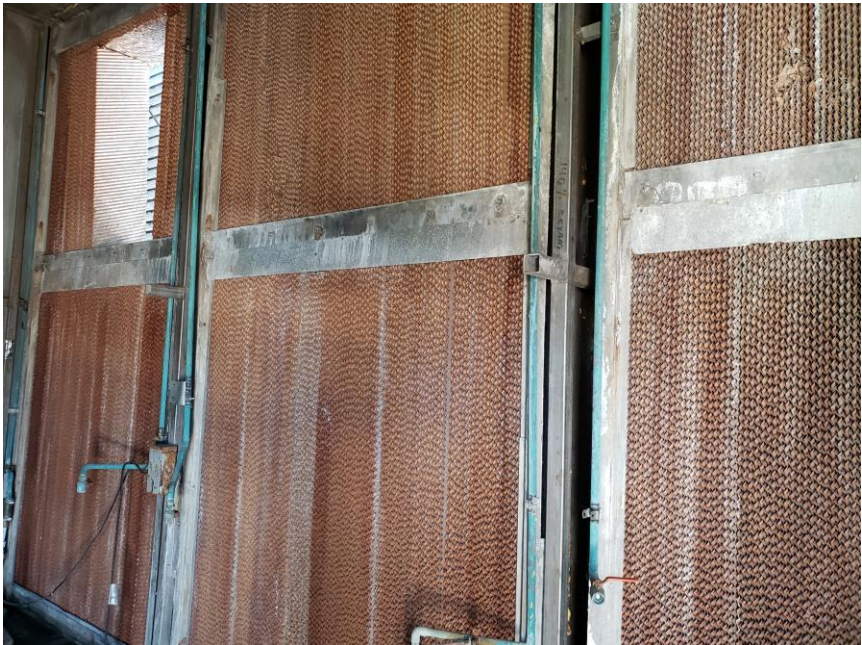
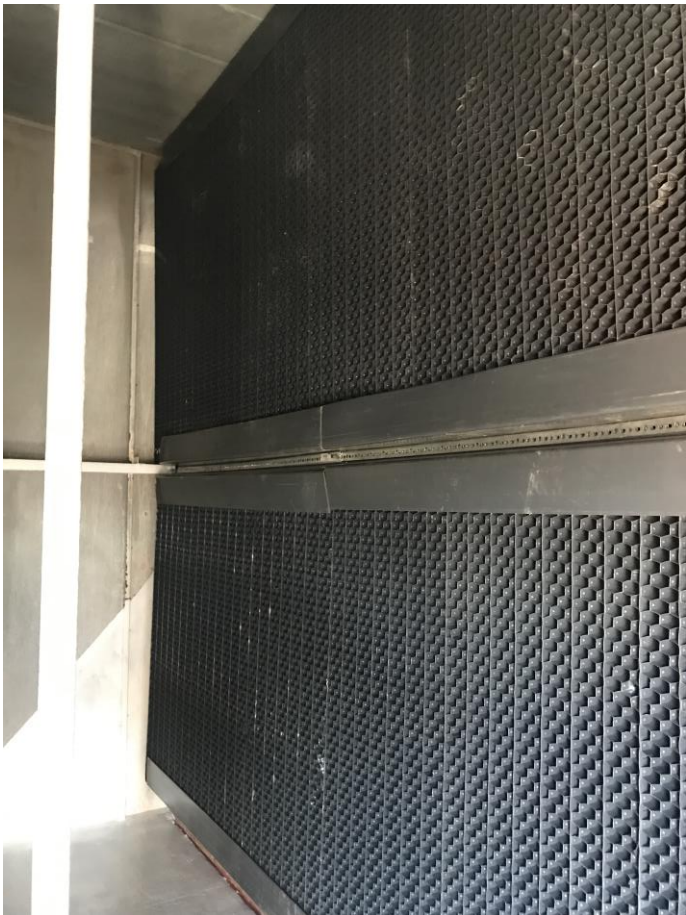
Above is a before and after view of the media area with the drift eliminators installed.

The cell-dek media on this unit was in decent shape but didn't fit into the rack properly which is why it has fallen out.

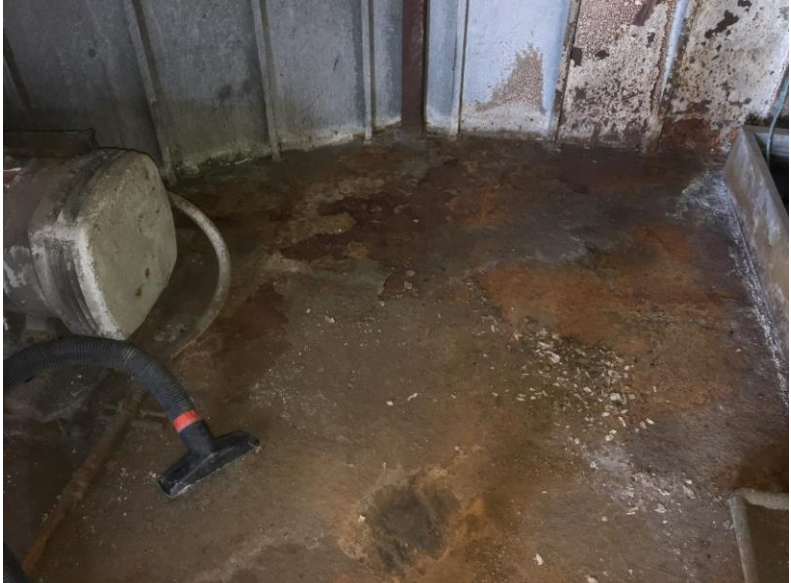
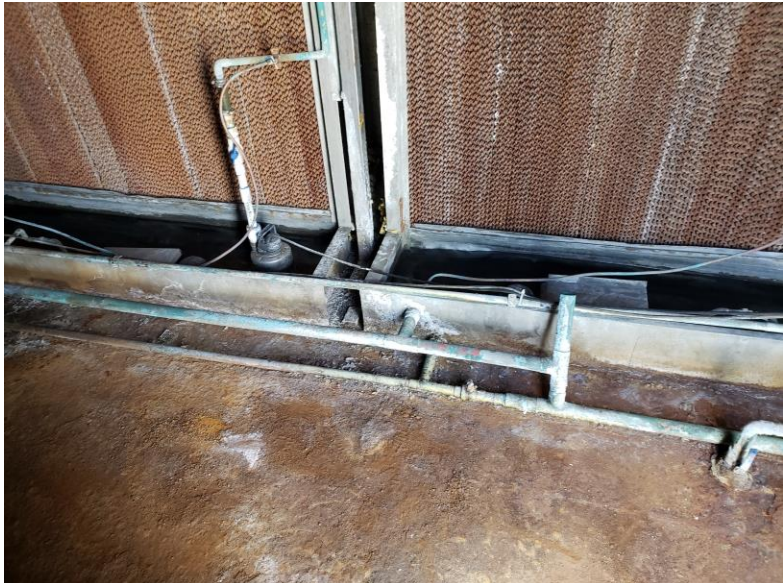
Above are 2 different views of how badly the floor and walls were corroding before.

We started this process by removing all excess debris, dirt and corrosion from the floors and motor supports with grinders, surface prep tools, scrapers, brooms and shop vacs. This was the most tedious part of the project due to the amount of corrosion built up all over the supports and floor. We removed over 25 gal. of material from the unit. The unit was gone through and any major holes were patched. After a unit was completely prepped and taped off the application of our RCI-A rust reformer & primer was applied to the motor supports and floor supports (which had the most corrosion). This was done to add another layer of sealant to the units and encapsulate the rust we didn't have access to and prevent any growth. After the RCI was applied we then cleaned all the surfaces to be coated to ensure the metal we were coating was free from any debris or dust to get proper adhesion and bonding. Then we applied our adhesion promotor to the entire surface to help promote a strong bond with the Tower-Guard Coating and the metal. The unit was then "cut" in by coating all the borders, supports and harder to reach areas. During the cutting process we added poly-fab to the seems to add an extra layer of strength to the areas of the floor with the most stress. This gives those seems an extra 3-4 times the tensile strength and flexibility in worst case scenarios. This was done before coating the floor to ensure all areas would be coated properly and make it easier to apply the coating to the flooring. We then applied the coating to the entire floor with an even coat.

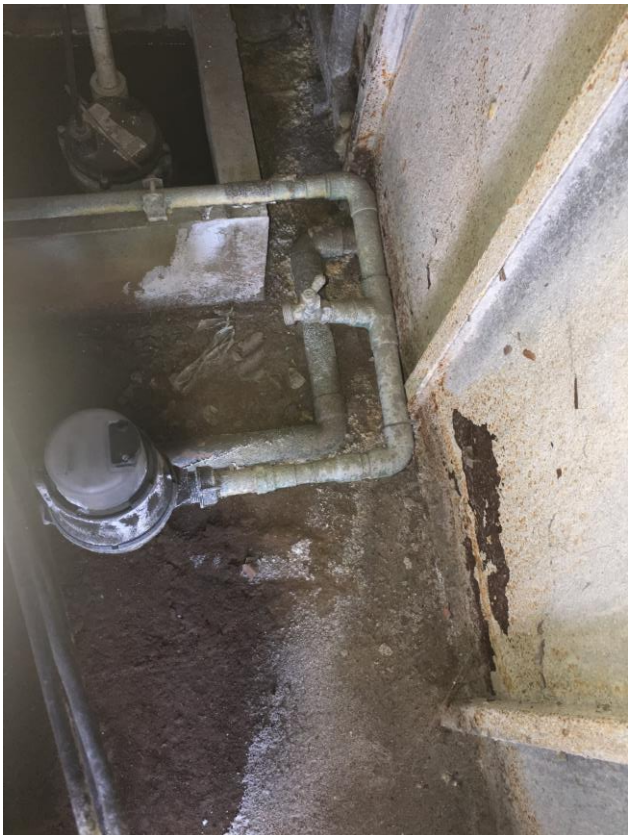
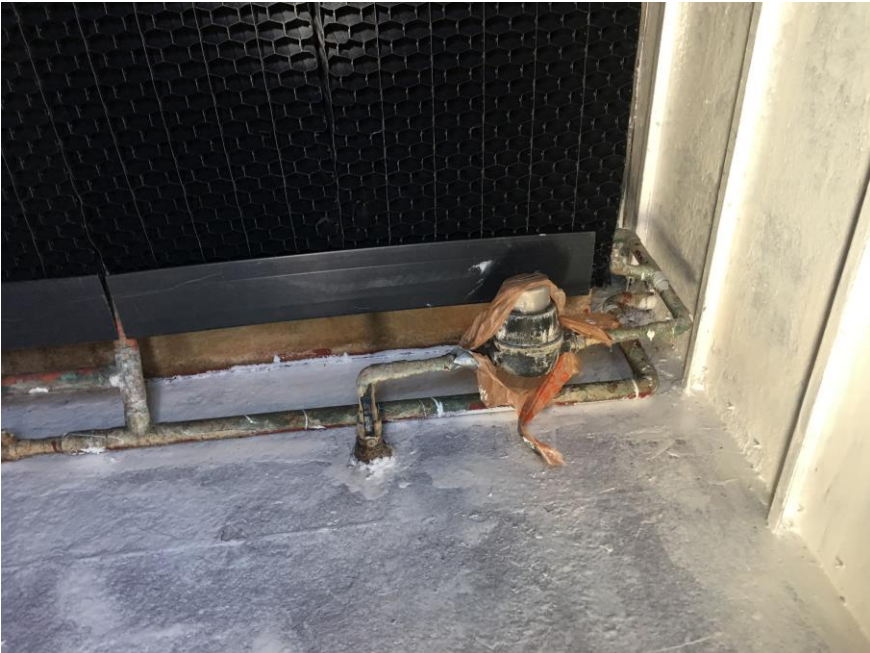
Above is a before and after view of the area around the piping and tight to the wall that we were able to seal.

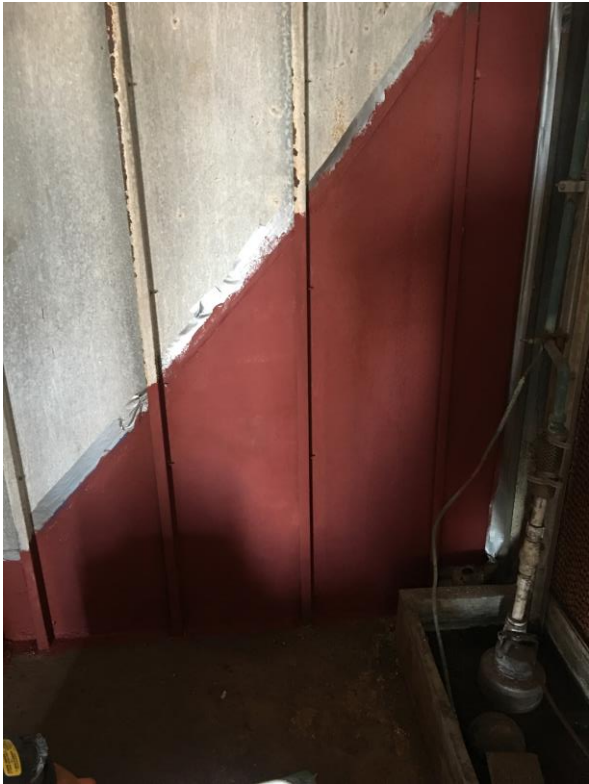
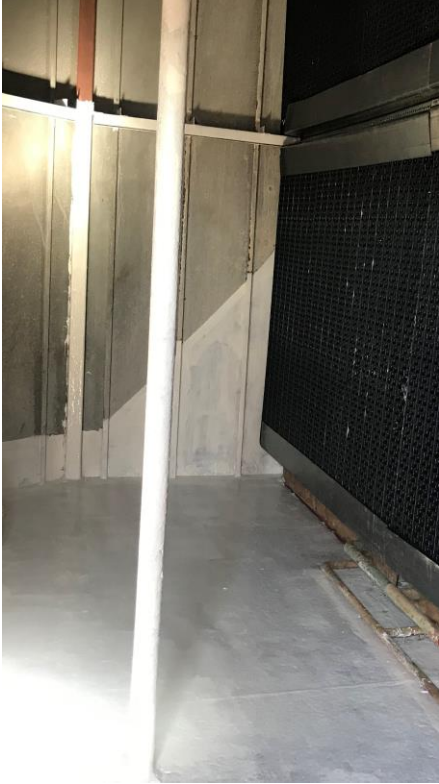
East wall RCI-A then Coated.

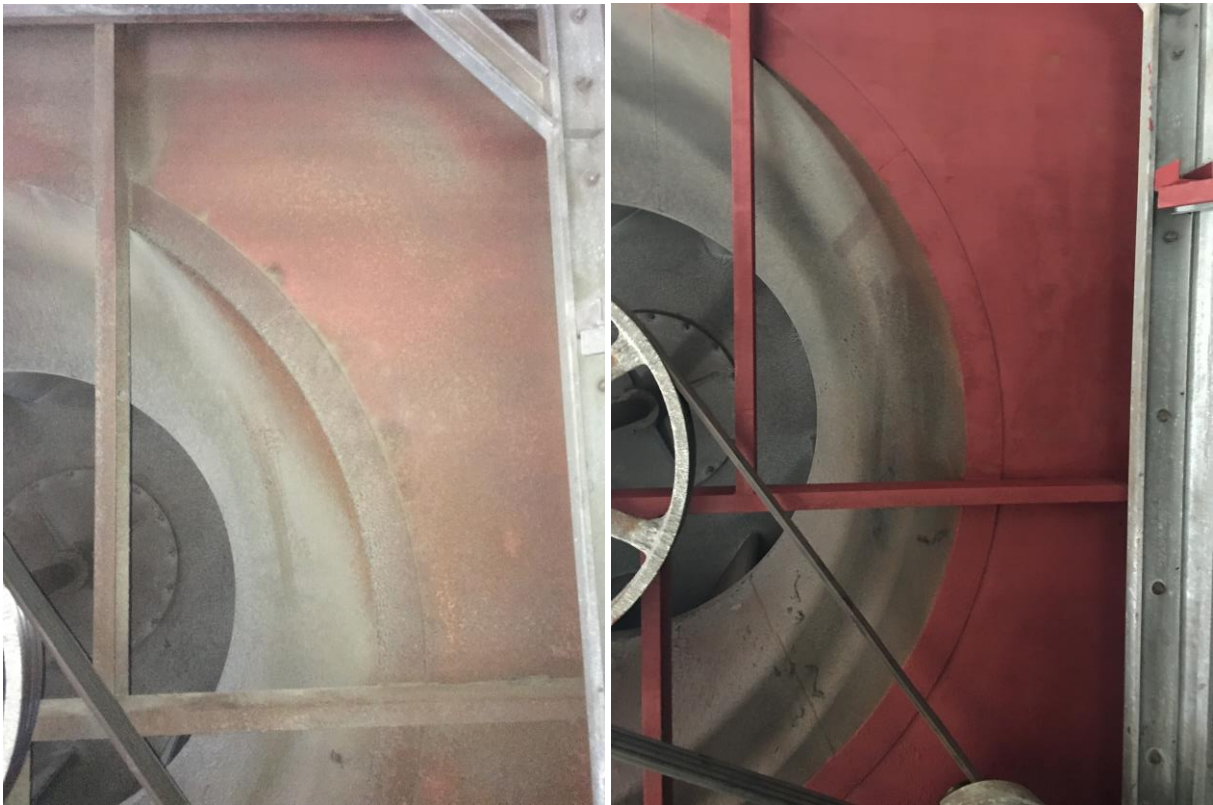
Area around fan housing before, with RCI-A applied then fully coated.

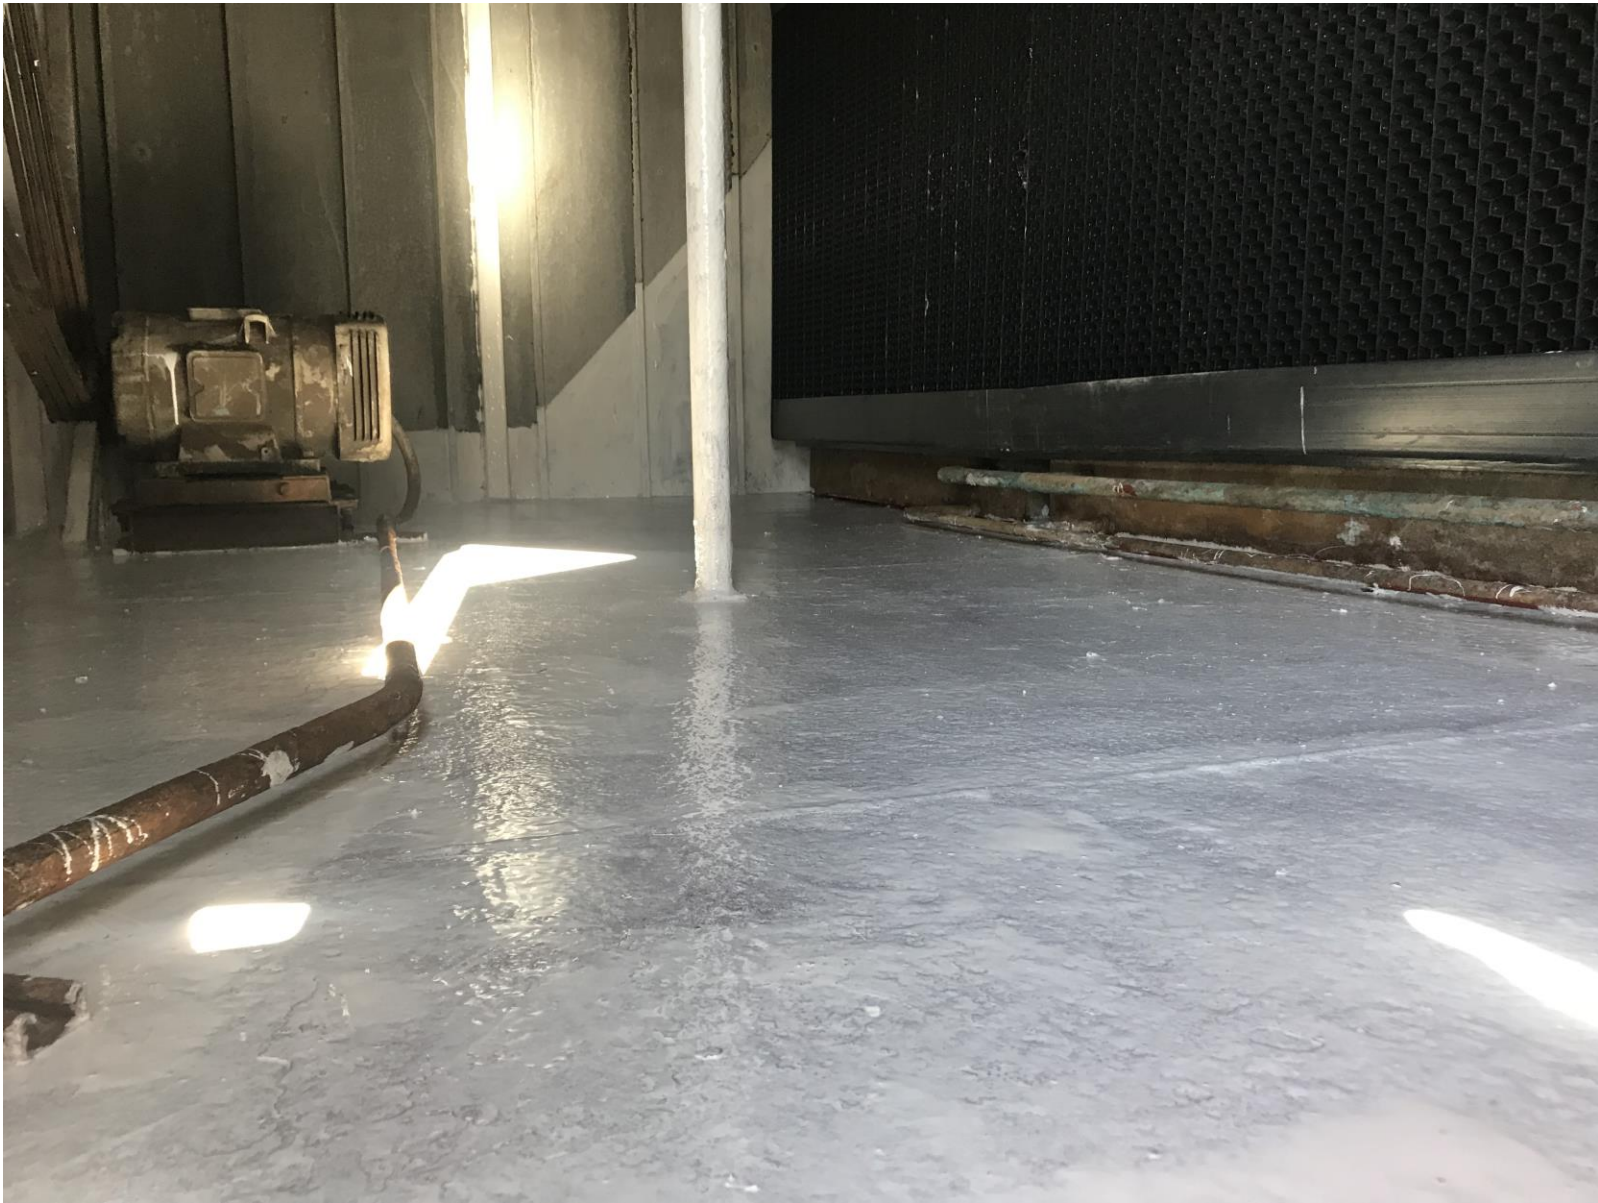
Floor completed and sealed.
